Summary Report

Upper Mt. Emu Creek Flood Investigation

Glenelg Hopkins CMA

06 August 2020

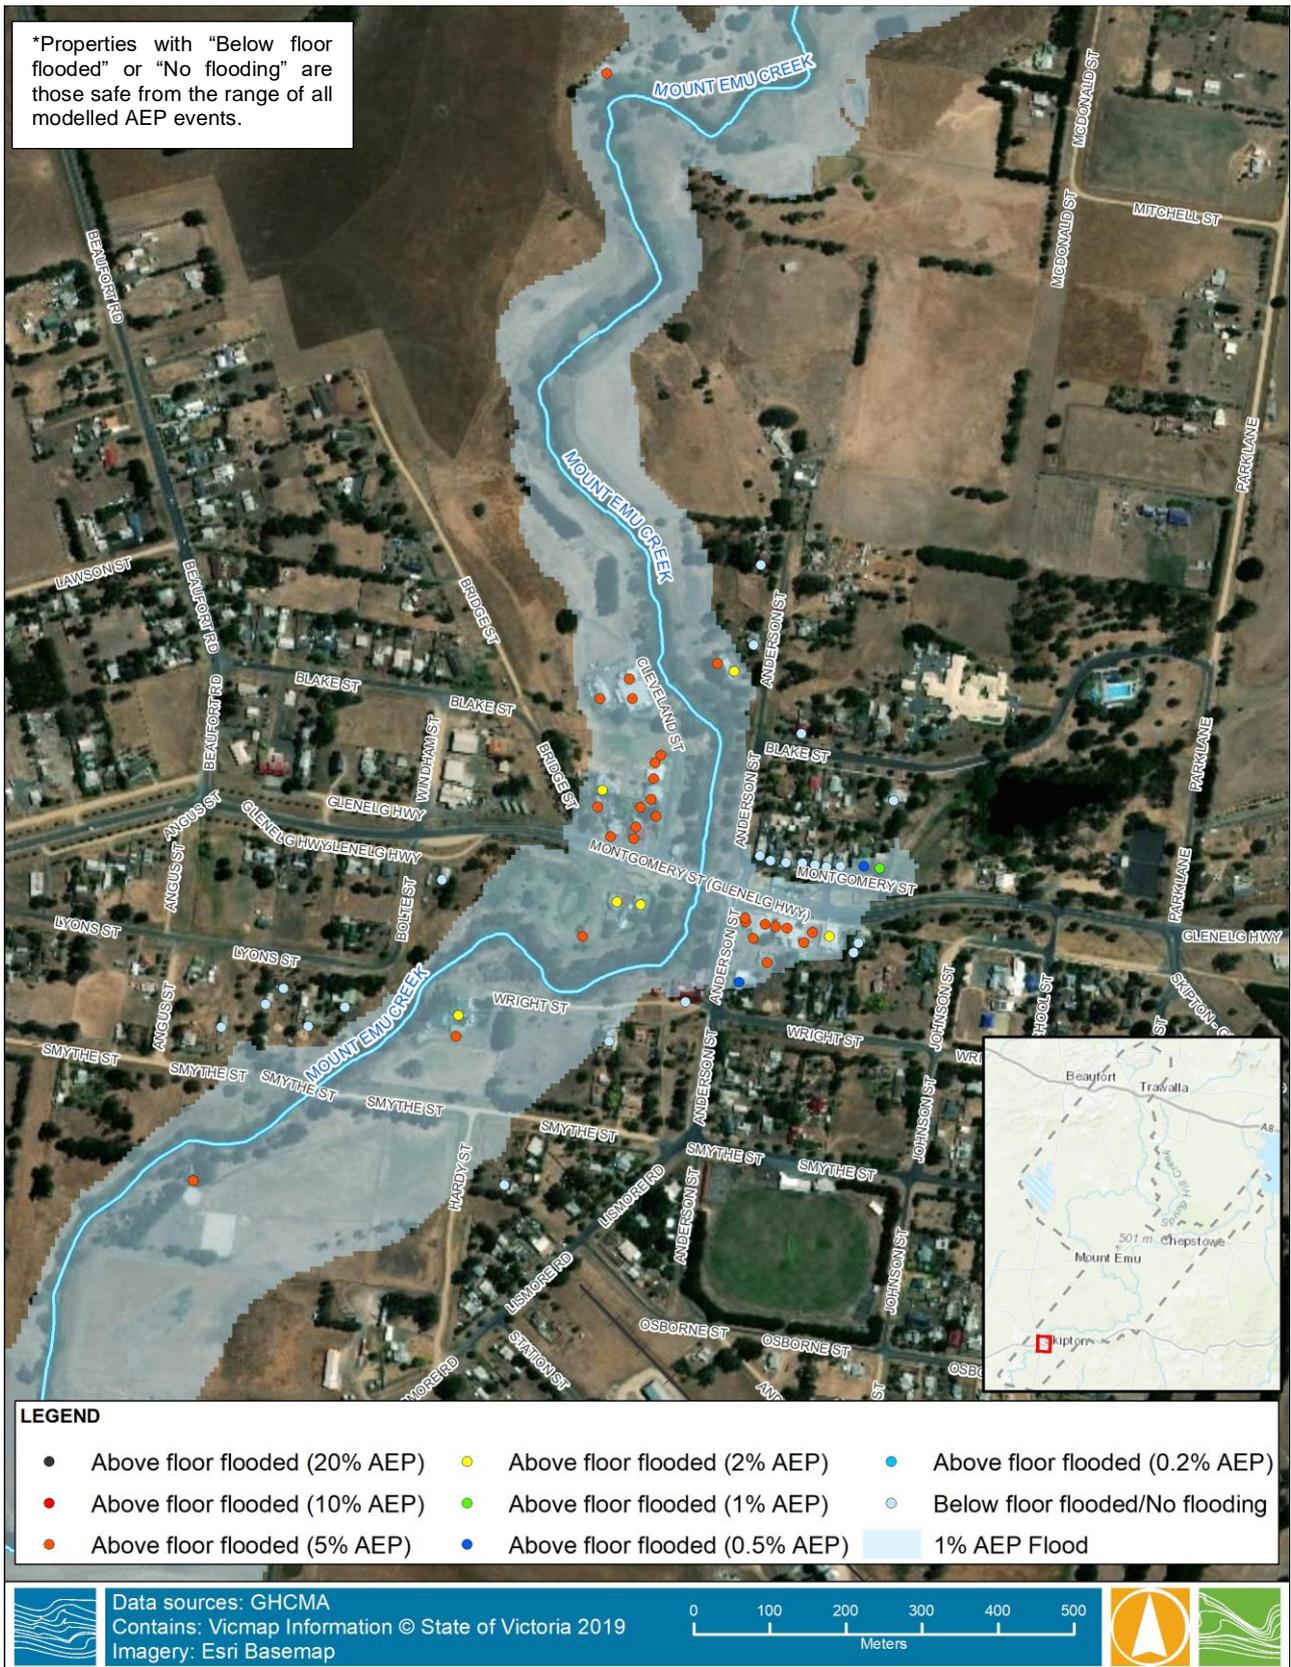
*Properties with "Below floor flooded" or "No flooding" are those safe from the range of all modelled AEP events.

FIGURE 5-2 PROPERTIES FLOODED ABOVE FLOOR DURING A RANGE OF AEP EVENTS (SKIPTON)

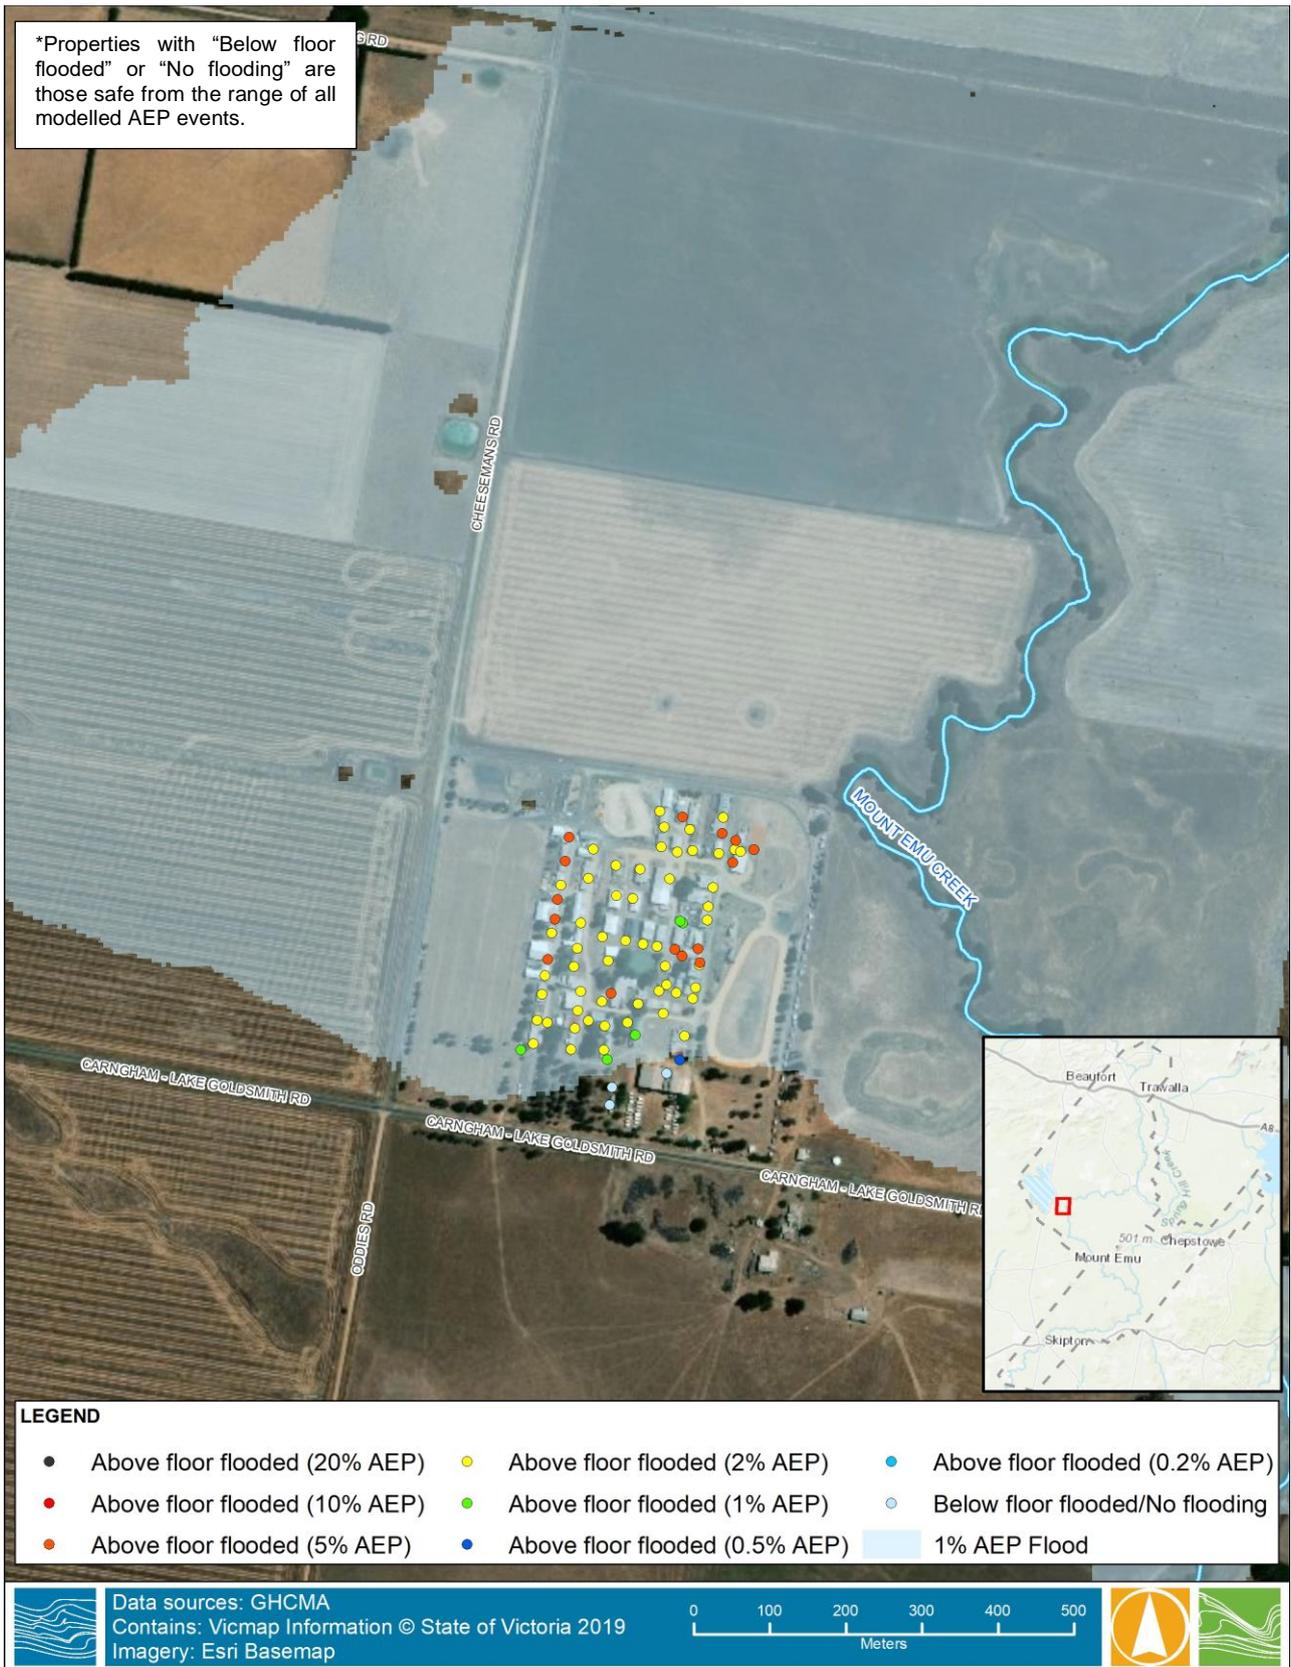
*Properties with "Below floor flooded" or "No flooding" are those safe from the range of all modelled AEP events.

FIGURE 5-3 PROPERTIES FLOODED ABOVE FLOOR DURING A RANGE OF AEP EVENTS (LAKE GOLDSMITH)

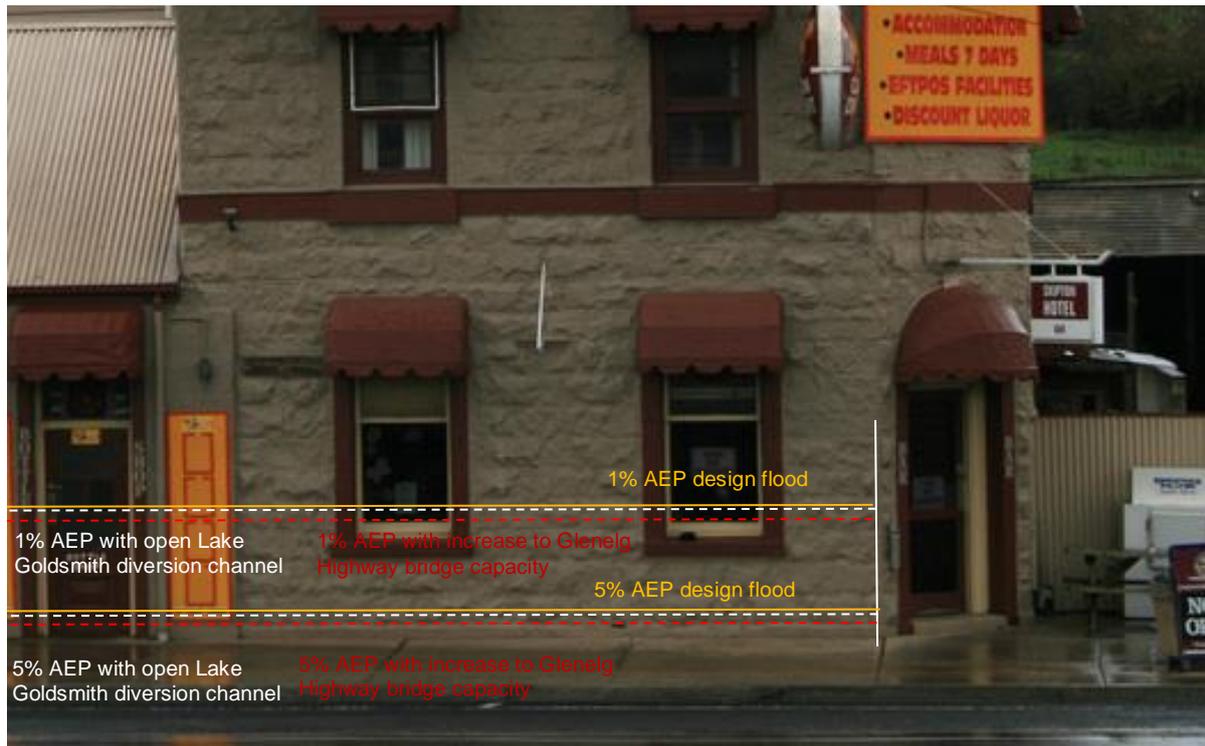
In a 1% AEP event, these properties are inundated to depths exceeding 0.5 m. Increasing the size of the bridge or opening the Lake Goldsmith diversion channel (option 4) do not reduce the level of flood risk or damage likely to be experienced at Skipton according to the results of the modelling assessments. Figure 6-1 below provides a visual representation of this in relation to the likely change in the 1% and 5% AEP flood levels at the Skipton Hotel.

FIGURE 6-1 DEMONSTRATION OF THE REDUCTION IN ABOVE FLOOR INUNDATION AT THE SKIPTON HOTEL
